REPAIR METHOD

for damaged fiber anchored gaskets

REPAIR METHOD FOR DAMAGED FIBER ANCHORED GASKETS

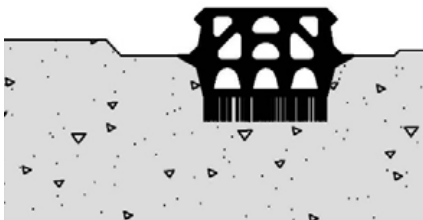
Installation situation of fiber anchored profile

In case of damages caused by mechanical impact during transportation and storage (cuts, breaks, etc.) the sealing gasket has to be replaced at least partially. This can be done by cutting off the sealing profile at its anchoring fibers as shown below, followed by replacing this removed section by conventional "brush-on" contact gluing procedure.

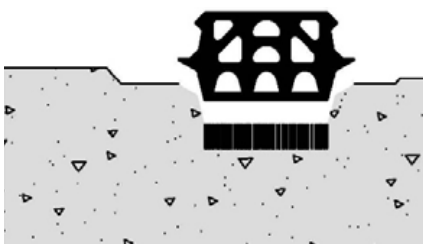
Groove section after removal of damaged profile

Repair profile to be inserted and glued in

The repair should be carried out exclusively in the right joint (Minimum distance from the corner 400 mm). Corners can't be repaired. We recommend for best results the using of adhesive G 3000 plus or FP 75. If necessary, there will be restrictions of use properties.

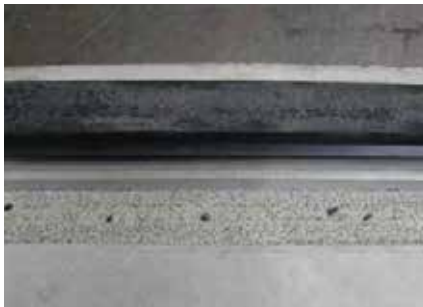
1 | REMOVE DEFECTIVE GASKET SEGMENT

Cut out the damaged gasket area in a 90° angle by means of a sharp knife. Clean the cut area of loose adhesive and fibers.

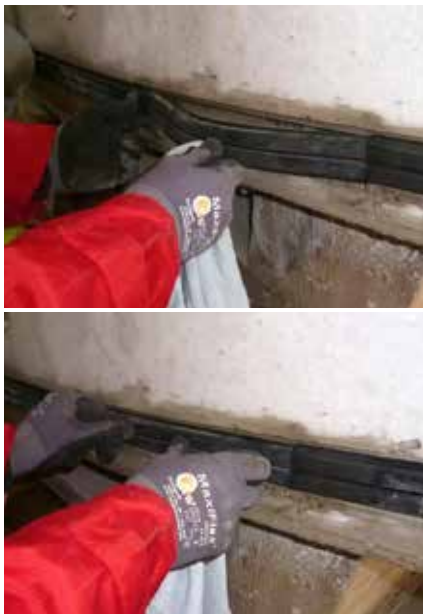
2 | CORRESPONDING SECTION

A corresponding section of that profile in perfect condition has to be cut to length. In order to achieve a good fit, the new profile piece has to be cutting the ends in a proper 90° angle and with approximately 2 % longer.

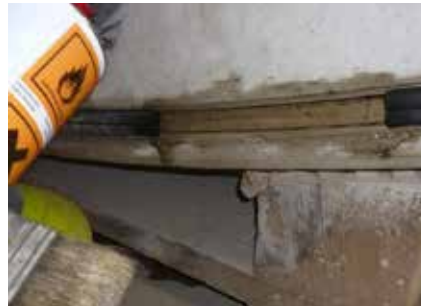
3 | CLEANING THE GROOVE

Clean concrete segment groove and bottom of profile (contact surfaces) with the SEALABE Cleaner G 3000.

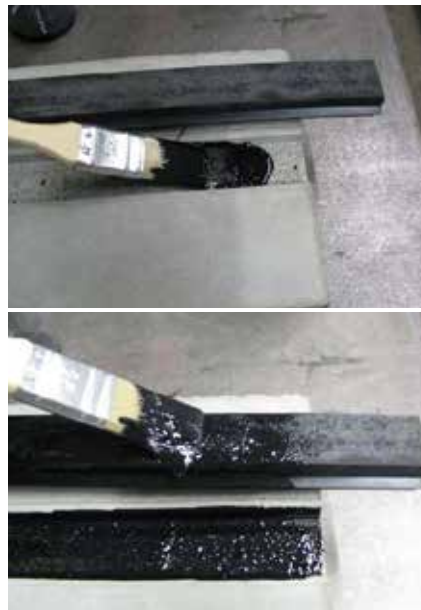
4 | COVER WITH ADHESIVE

Lift the end of each side of the area where the new gasket piece should be inserted approx. 10 to 15 cm in order to apply the adhesive (G 3000 plus or FP 75) to this complete area. In addition, the adhesive (G 3000 plus or FP 75) must be applied in the groove of the damaged area and also on the side flanks and bottom of the profile.

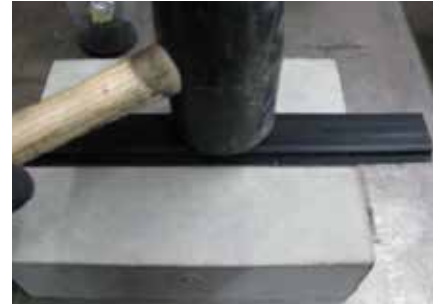
5 | FIT AND FIX THE NEW PROFILE PIECE

Insert the new profile piece into the cut section. Apply pressure to the inserted profile piece and the lifted profile area with a rubber mallet.

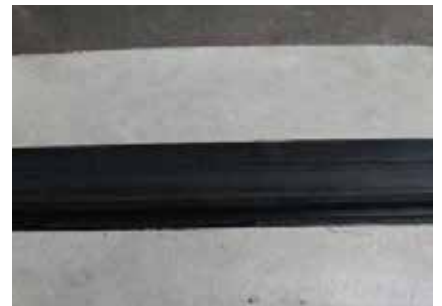
6 | CONTROL

Check the gasket repaired for stiffness and then it can be used.
